EVALUATION REPORT 353

CO-OP IMPLEMENTS 742 SELF-PROPELLED WINDROWER

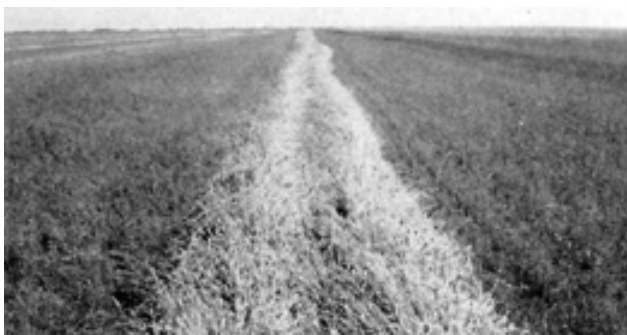
FIGURE 7. Wheat: 30 bu/ac (2.0 t/ha).

Windrow Formation: Windrows may be classified into four general patterns (FIGURE 6), although many combinations and variations exist. FIGURES 7 to 11 show typical windrows formed by the CI 742. The CI 742 produced parallel and fantail windrows in most grain crops. Wheat and barley windrows were usually formed in two parts. Herringbone windrows occurred in light crops, while fantail windrows were predominant in heavy, tall stands or ripe crops. In thin stands, reducing draper speed resulted in a wider, more parallel windrow.

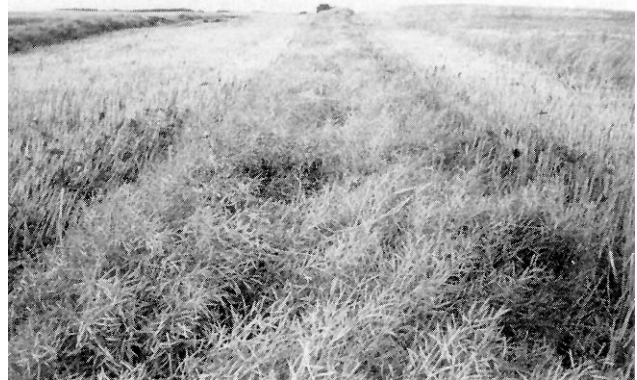
FIGURE 10. Rapeseed: 30 bu/ac (1.7 t/ha).

Parallel and fantail were the predominant windrow types formed. In leaning crops, parallel and angled parallel windrows occurred. Windrows were typically 6 to 7 ft (1.8 to 2.1 m) wide. Some bunching occurred when rapeseed caught on the centre divider and when tall crop caught on the flotation springs by the windrow opening.
